KATY ALLEN LAKE DAM
VERNON COUNTY, MISSOURI
MO 20207

PHASE 1 INSPECTION REPORT NATIONAL DAM SAFETY PROGRAM

KATY ALLEN DAM
VERNON COUNTY, MISSOURI
MISSOURI INVENTORY NO. 20207

Name of Dam:	Katy Allen Dam
State Located:	Missouri
County Located:	Vernon County
Stream:	Willow Branch
Date of Inspection:	21 June 1979

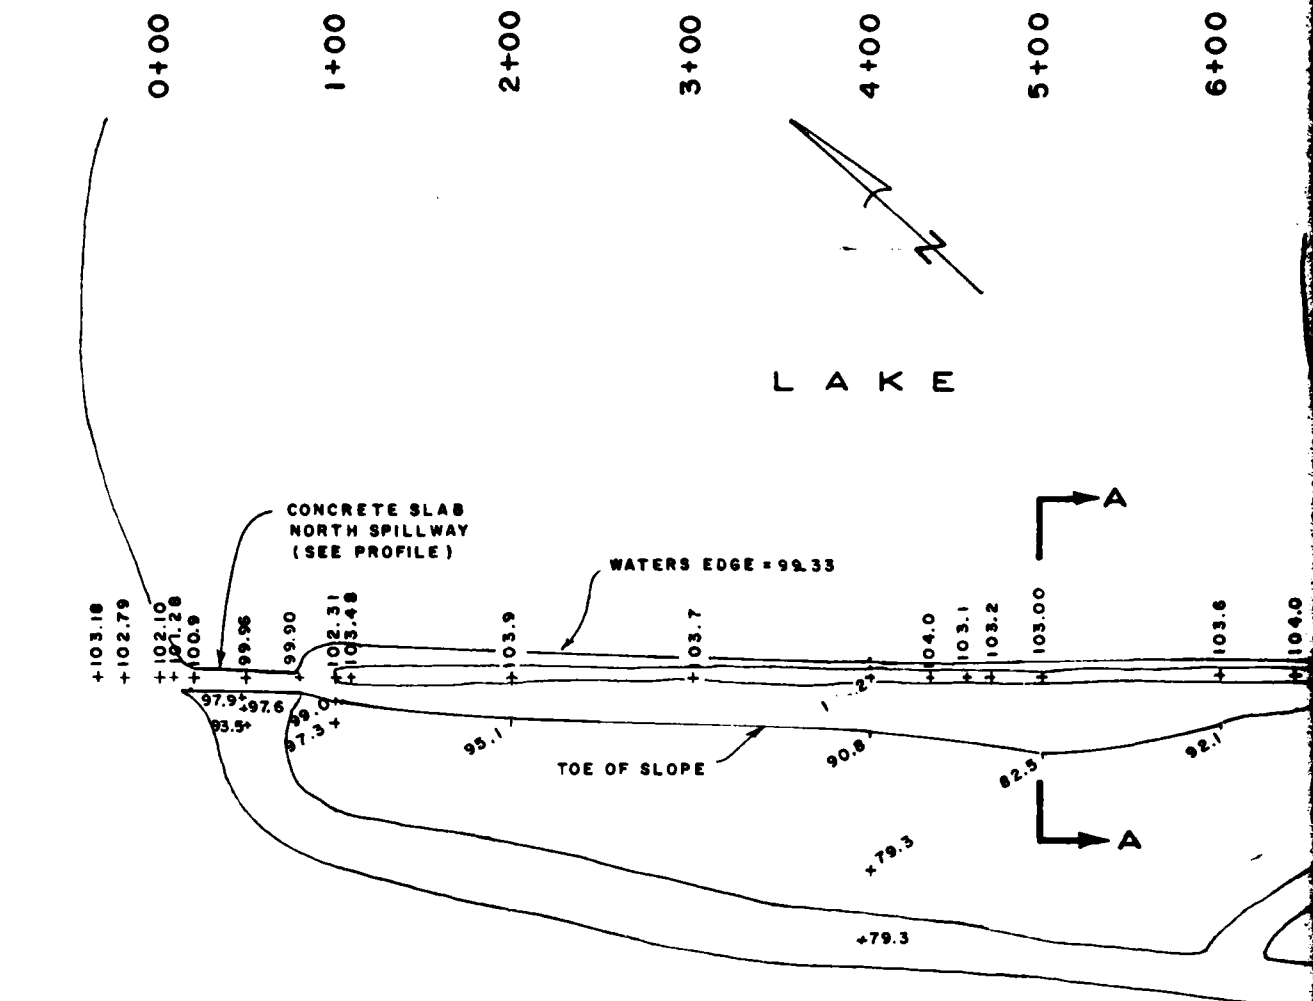
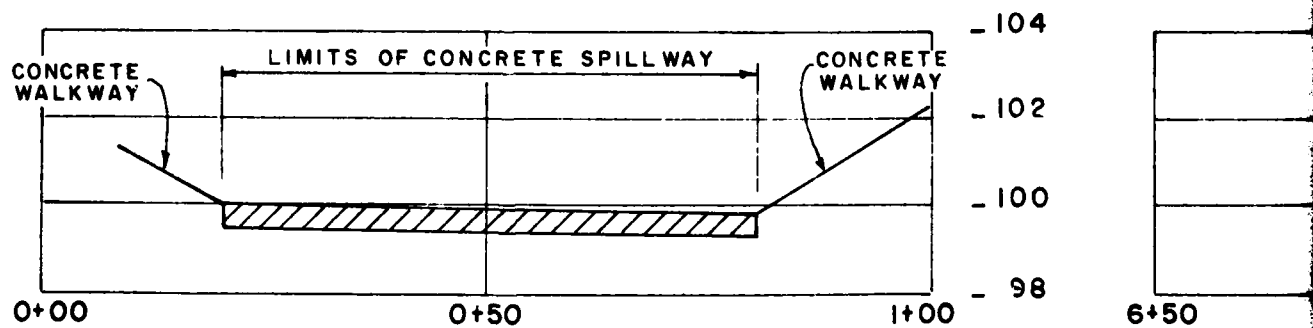
NORTH SPILLWAY PROFILE

The approach to the north spillway is open except for considerable plant growth in the water. The concrete control section is undermined but appears to be stable at this time. The control section should be inspected to determine the extent of the undermining. The concrete spillway section is badly broken and water flows under the slab. The spillway below the concrete section is well away from the embankment and the base has eroded down to sandstone bedrock.

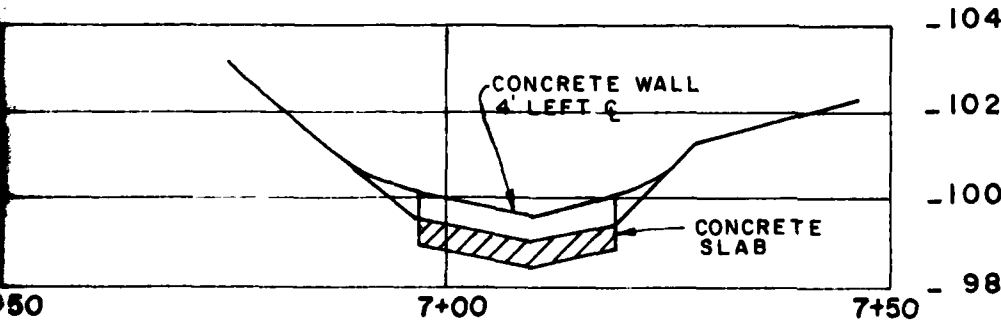
SOUTH SPILLWAY PROFILE

The approach to the south spillway has a 2 foot diameter tree in the middle of the channel. Concrete control wall appears in fairly good shape. The section should be checked for possible undermining. Concrete channel below crest is badly weathered, broken and apparently undermined. The spillway below the concrete section is well away from the dam and the base has eroded down to sandstone bedrock.
